FordFiesta

Your Technical Supplement 21

Engine idle undershooting or stall when coming to a stop / engine low idle when the engine is warm

3rd gear crashing during shifting into 3rd gear

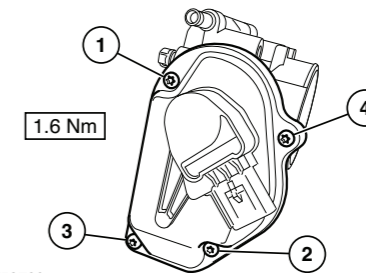
4. CAUTIONS:

- Open the cover in a clean environment to make sure no contamination enters. Care must be taken when removing the cover as it is possible for a gear to fall out. Do not apply any load to the TP sensor during assembly
- TP sensor screws are installed using locking compound and could shear when removing. To prevent this, the screws should be partially removed by two or three revolutions then tightened again
- Install a new TP sensor with four new screws
- Tighten the screws in the sequence shown
