Oil leakage into air cleaner

Model: Fiesta 2001+

Ford Fiesta – Engine/Steering

Your Technical Supplement 14

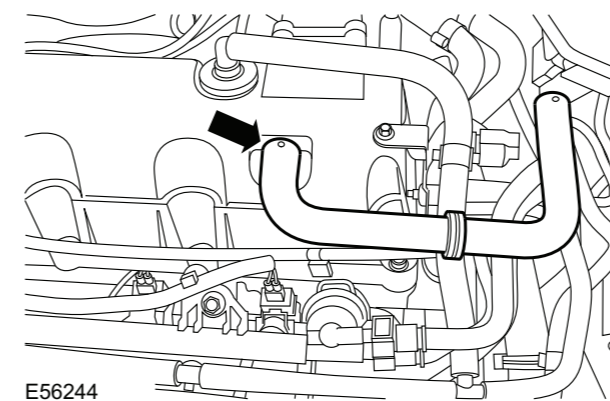
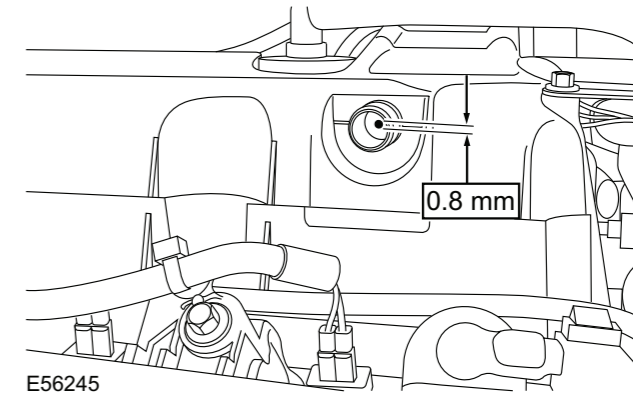
E56245

Summary: Inadequate oil return within the valve cover in conjunction with high levels of crankcase exhaust gases can lead to engine oil leakage into the air cleaner housing via the positive crankcase ventilation hose connected to the valve cover. Engine oil leakage from the air cleaner housing is expressed by the customer as a concern regarding loss of engine oil. It may at times lead to blue-smoke emission.

If a concern is expressed, a 0.8mm hole must be drilled in the intermediate wall of the valve cover. This results in a reduction of the air flow speed within the valve cover, preventing the engine oil from penetrating into the air cleaner housing via the valve cover.

1. Remove the air cleaner.
2. Disconnect the positive crankcase ventilation hose from the valve cover.
3. **NOTE:** Plastic residue resulting from drilling the hole will not adversely affect vehicle performance and does not need to be removed from the valve cover cavity.

- Drill a 0.8mm hole in the intermediate wall of the valve cover through the positive crankcase ventilation hose union.
4. **NOTE:** Only install a new air cleaner element housing if the contamination is attributable to engine oil leakage via the positive crankcase ventilation hose.

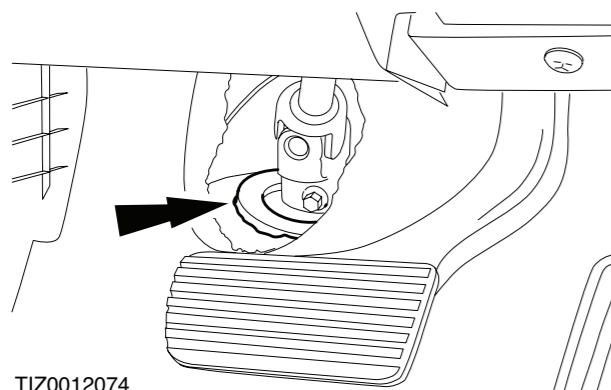
TIZ0012074

A. Insufficient lubrication of the coupling at the base of the steering column

1. Access the coupling at the base of the lower steering column.

2. Apply grease from repair kit (see Parts Required) to the lower column sealer at the dash panel.
3. Test for noise by turning the steering wheel in both directions.
 - If the noise is still present, go to next step.
 - If the noise is no longer present, no further action is required.

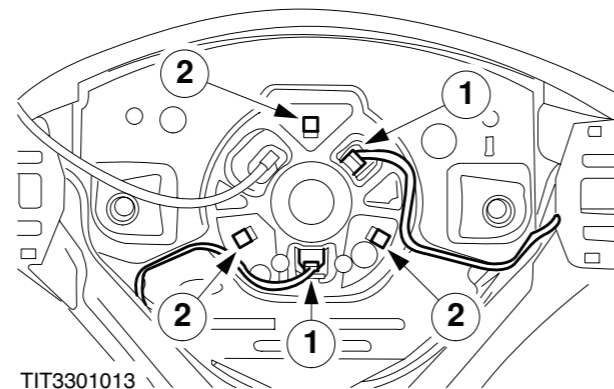
TIT3301013

B. Insufficient grease applied at the steering wheel clockspring for the multifunction contact pins or broken clockspring

1. Disconnect the battery ground cable.
2. Remove the steering wheel.
3. Make sure that the clockspring and contact pins are sufficiently greased (see Parts Required).
4. Rotate the clockspring in both directions to check for noise.
 - If the clockspring is noisy or damaged, go to next step.
 - If the clockspring is NOT damaged, go to step 9.

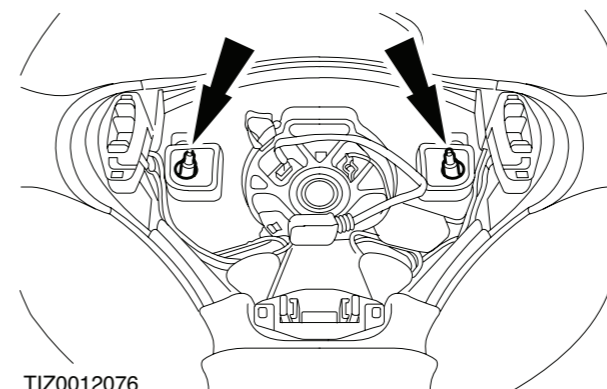
TIZ0012076

C. A touch condition of the drivers air bag fixing screws

1. Access the airbag fixing bolts.
2. Apply tape (see Parts Required) around the airbag fixing bolts.

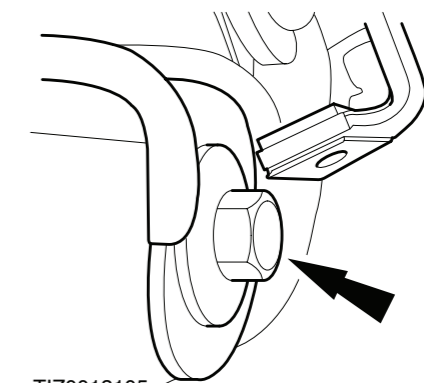
TIZ0012105

D. Touch condition of speed nut for fixing lower steering column

1. Turn the speed nut 90°
 - Make sure that the speed nut is NOT in contact with the instrument panel fixing screw.
