FordTransit

Your Technical Supplement 17

Smell in vehicle interior.

Uneven steering force; erratic steering pressure.

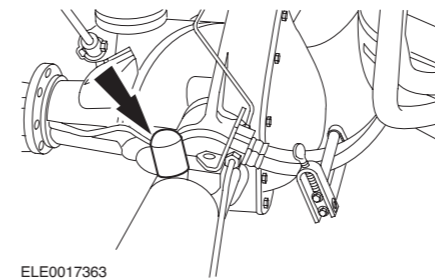
Summary: Should a customer express concern about an unacceptable smell in the vehicle interior, the probable cause is rear axle ventilation gases entering the vehicle. To rectify this concern, the rear axle ventilation hose should be replaced and re-routed to vent into a side member.

1. Raise and support the vehicle.
2. Remove and discard rear axle vent.

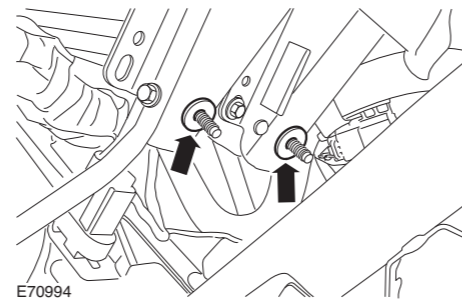
Summary: Should a customer express concern about uneven steering force or erratic steering pressure, the probable cause is misalignment of the steering column to the crossmember (part of the instrument panel).

- Install one washer (see Parts Required) to both lower threaded studs.

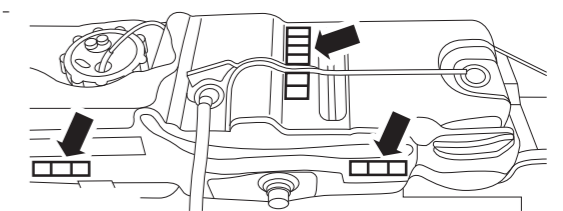
Summary: Should a customer express concern that there is a knocking noise from the floor area above the fuel tank, particularly under braking or during low speed manoeuvres, the probable cause is fuel impacting on the rear surface of the fuel tank and the noise being transmitted through the floorpan. To rectify this concern, noise, vibration and harshness (NVH) pads should be installed.

- Install the 12 fuel tank NVH pads (see Parts Required).
