**FordKA**

# Your Technical Supplement 22

## Front suspension noise

# Corrosion spots on the tailgate around the opening for the rear window wiper motor

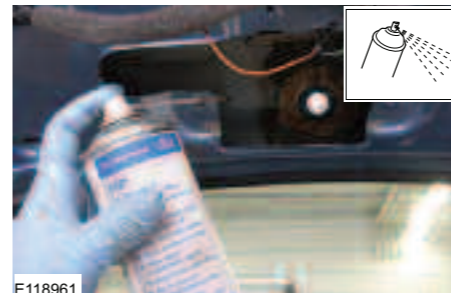
15. Apply 2K-Acrylic-Filler as specified by the manufacturer and prepare the tailgate for paint

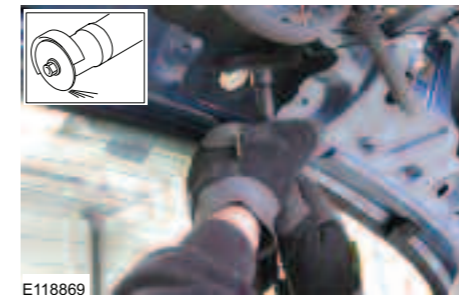
9. Remove any corrosion on the outside of tailgate sheet metal using a narrow, coarse rotating wire brush or suitable tools
