FordFiesta

Your Technical Supplement 21

Engine idle undershooting or stall when coming to a stop / engine low idle when the engine is warm

3rd gear crashing during shifting into 3rd gear

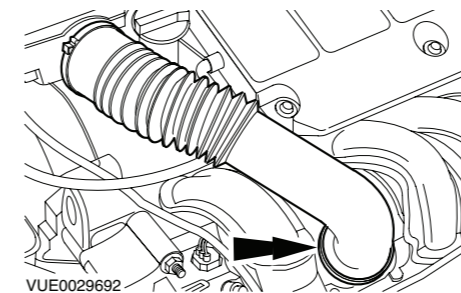
Summary: Should a customer express concern about the engine idle undershooting or stall when coming to a stop / engine low idle when the engine is warm, one of the probable causes is fretting corrosion on the pins within the Throttle Position (TP) Sensor. To rectify this concern, a new TP sensor in conjunction with a new fuel charging wiring harness with gold plated pins and connector should be installed

1. Disconnect the air cleaner outlet pipe from the throttle body
