Oil leakage into air cleaner

Model: Fiesta 2001+

Ford Fiesta – Engine/Steering

Your Technical Supplement 14

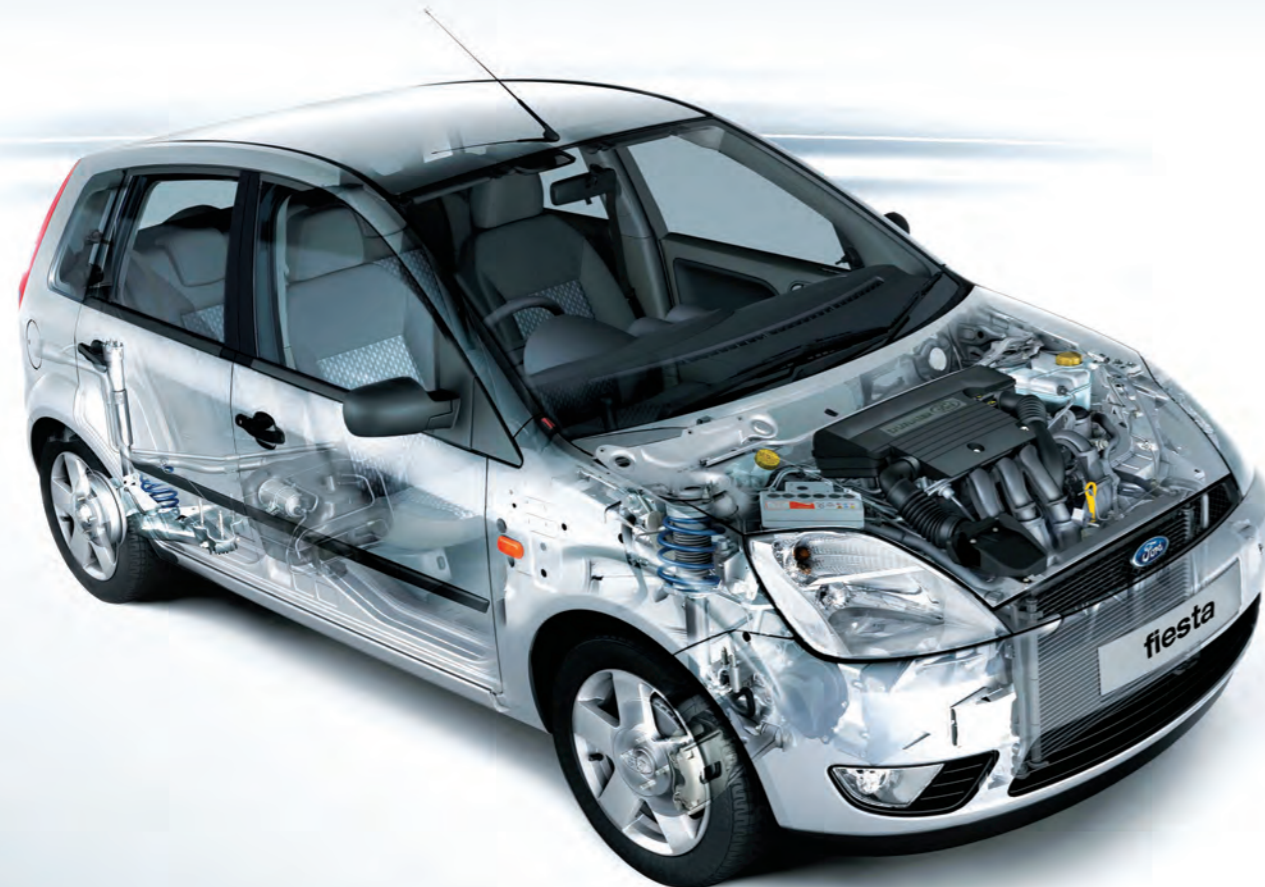
E56245

Summary: Inadequate oil return within the valve cover in conjunction with high levels of crankcase exhaust gases can lead to engine oil leakage into the air cleaner housing via the positive crankcase ventilation hose connected to the valve cover. Engine oil leakage from the air cleaner housing is expressed by the customer as a concern regarding loss of engine oil. It may at times lead to blue-smoke emission.

1. Remove the air cleaner.
2. Disconnect the positive crankcase ventilation hose from the valve cover.
3. **NOTE:** Plastic residue resulting from drilling the hole will not adversely affect vehicle performance and does not need to be removed from the valve cover cavity.

- Drill a 0.8mm hole in the intermediate wall of the valve cover through the positive crankcase ventilation hose union.
4. **NOTE:** Only install a new air cleaner element housing if the contamination is attributable to engine oil leakage via the positive crankcase ventilation hose.

- Check the air cleaner element and positive crankcase ventilation filter for oil residue contamination; replace if necessary (see "Parts Required"). Check the air cleaner housing for oil residue contamination. Air cleaner housings contaminated with engine oil cannot be cleaned and a new housing must be installed (see "Parts Required").

5. Install the components.
