FordTransit

Your Technical Supplement 17

Smell in vehicle interior.

Uneven steering force; erratic steering pressure.

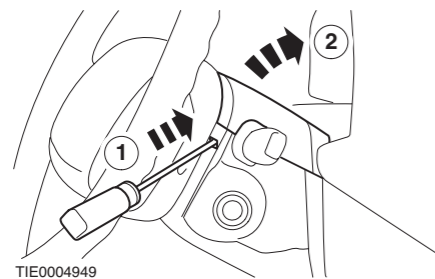
- NOTE:** Turn the steering wheel to gain access to the steering column upper shroud retaining clips. Remove the steering column upper shroud
 - Using a thin bladed screwdriver, release the two clips (one each side).
 - Remove the shroud.

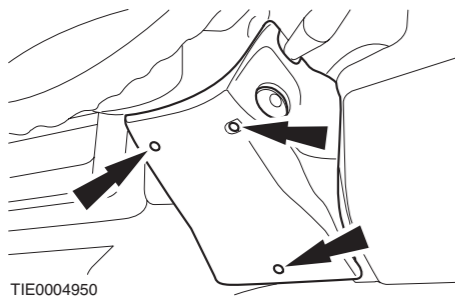
- Remove the steering column lower shroud.

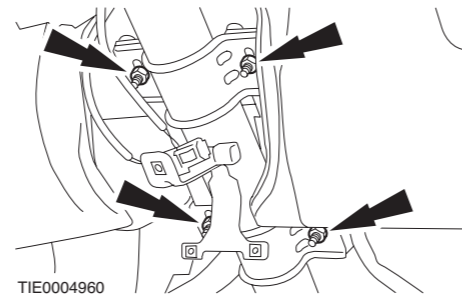
- Remove the steering column retaining nuts and partially lower the steering column.
 - Discard the nuts.

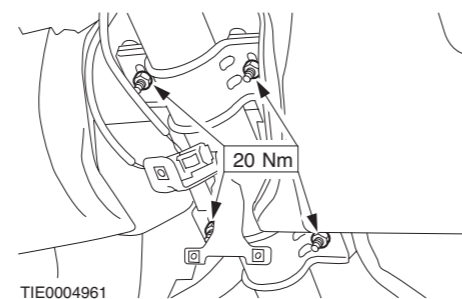
- WARNING:** Install new steering column locknuts (see Parts Required). Failure to follow this instruction may result in personal injury. To install, reverse the removal procedure.

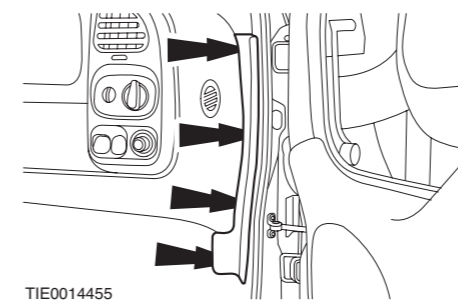
- Remove the instrument panel side trims (right-hand side shown).
 - Partially remove the door weatherstrip.
 - Detach the clips.

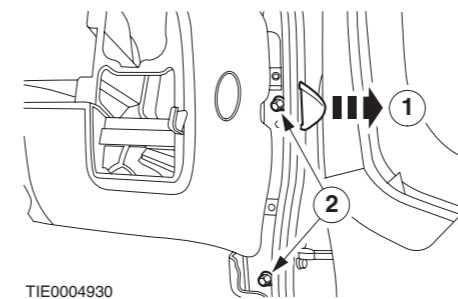
- Remove the instrument panel side lower retaining bolt and loosen the upper retaining bolt (right-hand side shown).
 - Remove the bolt covers.
 - Remove both lower bolts and loosen both upper bolts.

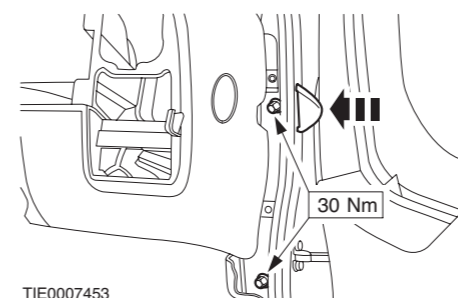
- To install, reverse the removal procedure.
